PRE-LOAD TEST EVALUATION RESULTS

PERFORMED AT: **C**
side
29-33 Newbury St Boston MA

INSPECTION DATE **January 14 2025**
REPORT DATE **March 10 2025**
REPORT EXPIRES **April 10 2025**

PRE-LOAD TEST INITIAL EVALUATION PASS/FAIL REPORT

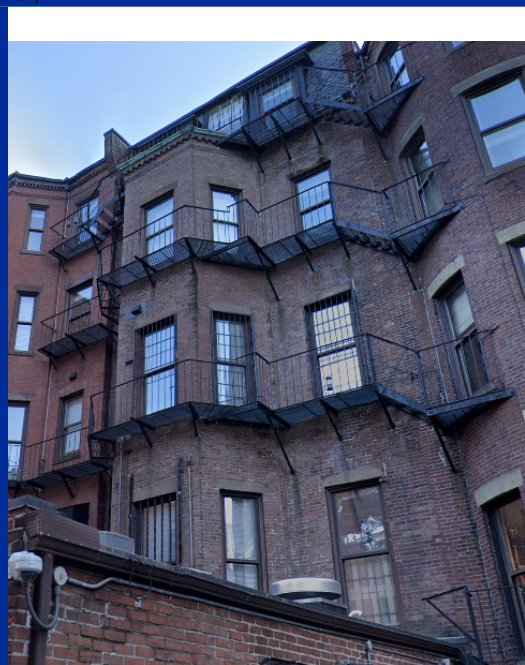
1. Overall Structural:

Poor/Fail

50%

Supports - Existing 3/8" hardware on structural supports is undersized by modern standards and should be replaced with minimum 1/2" Grade 5 or A307 bolts to meet safety compliance; signs of internal rust and potential section loss were observed.

Grating/ Platforms - Severe rust jacking was detected at platform connections and spacers, indicating trapped moisture causing expansion.

Rails - Several railings are structurally deficient, with loose or deteriorated fasteners, and lack the required lateral strength to withstand the 200 lb. horizontal load test.

Stringers - Internal rust is causing rust jacking in stringer clip connections.

Treads - Rust jacking and deterioration in the spacers are present in numerous treads, increasing the risk of structural failure; securing all treads with bolted connections rather than welds is recommended.

Cement/ Footings - The load-bearing masonry wall supporting the fire escape is deteriorating, creating a high-risk failure point; temporary shoring may be necessary during repairs, and epoxy injection or repointing may be required for structural stability.

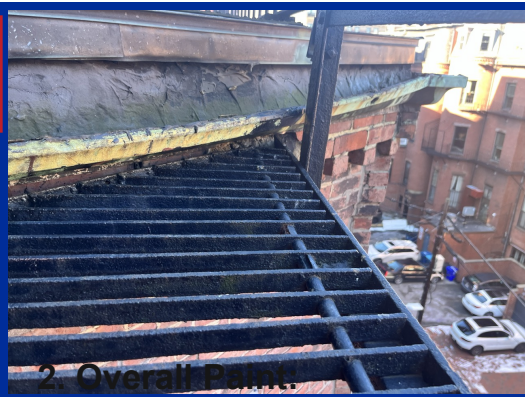
2. Overall Paint:

Overall Paint FAIL. Lack of routine maintenance requiring Full scrape, prime, seal, and paint.

Overall Paint FAIL: EPA rules apply for Lead Paint 1978. Renovator's license required. Welding not approved as repair method.

Poor/Fail

50-75%

Overall the paint FAIL: Full paint on system required after repairs. Recommend to power wash and seal all major joints to prevent water intrusion into structural connections.

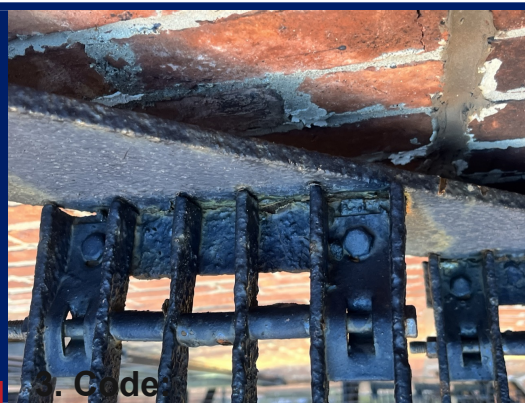
3. Code:

Issues Exist

25%

Our inspector found code issues related to AHJ (Authority Having Jurisdiction) or PENC (pre-existing non-conforming) requirements for this Fire Escape system.

- Missing catwalk in two locations
- Lighting may require upgrade to satisfy code requirements.
