PRE-LOAD TEST EVALUATION RESULTS

FAILED MINOR

PERFORMED AT: **E**
side
31 Newbury St (Roof) Boston MA

INSPECTION DATE **January 29 2025**
REPORT DATE **March 10 2025**
REPORT EXPIRES **April 10 2025**

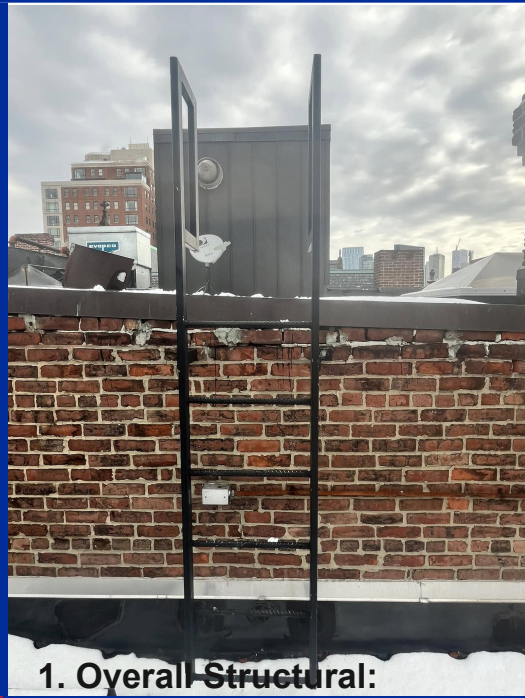
1. Overall Structural:

Issues Exist

25%

This is a five story brick building with a fire escape system made of steel and aluminum and consisting of ladders to a neighboring roof that acts as a dispersal area. This system did not pass due to the following minor issues:

- The wall supporting the exterior fixed ladder requires repairs to ensure structural stability and safe egress.
- The interior ladder has sharp edges due to angled cuts at the top, posing a safety hazard. The edges should be smoothed or properly finished to prevent injury.
- The top few rungs of the interior ladder are not securely connected to the wall, reducing stability and increasing the risk of failure under load. A platform break should be installed at the top of the well as well as an additional ladder to transition from the platform to roof after the hatch deploys, if not, additional supports or wall anchors should be installed to reinforce the ladder and ensure safe use.

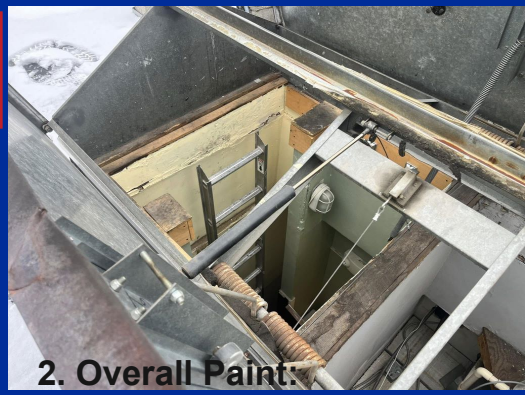
2. Overall Paint:

Fair

0-25%

Overall the paint PASS: Spot paint on system required after repairs. Recommend to power wash and seal all major joints to prevent water intrusion into structural connections. Fire Escapes, must be maintained/ painted every 5-7 years as per manufactures recommendation.

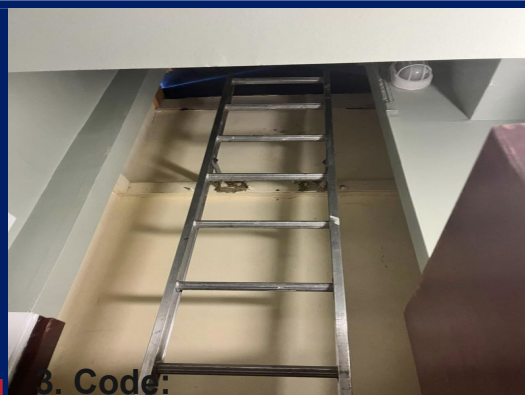
3. Code:

Issues Exist

75-100%

- The ladder providing access to the roof is located inside a bathroom closet, which is an unconventional and potentially non-compliant placement that may obstruct emergency egress. Relocation or an alternative means of access should be evaluated for compliance with safety regulations.

- The roof hatch is difficult to operate, potentially delaying evacuation in an emergency. Proper maintenance or replacement with a code-compliant, single-action, easily operable hatch is recommended.

- There is no platform at the top of the access well, requiring individuals to stand on the ladder while opening the hatch. This creates a significant safety hazard. Installing a compliant landing platform is recommended to enhance safety and accessibility.

- The roof hatch lacks a transfer step, making it difficult and unsafe to climb onto the roof from the ladder. A properly designed and code-compliant transfer step should be installed to facilitate safe egress.

- The angle at which the hatch door rests creates a head obstruction when exiting.
- No visible emergency egress lighting is present, which may compromise visibility during an evacuation.
