## PRE-LOAD TEST EVALUATION RESULTS

PERFORMED AT: **C**  
side  
**35 Newbury St Boston MA**

INSPECTION DATE **January 14 2025**  
REPORT DATE **March 10 2025**  
REPORT EXPIRES **April 10 2025**

PREPARED BY:  
**FIRE ESCAPE ENGINEERS**

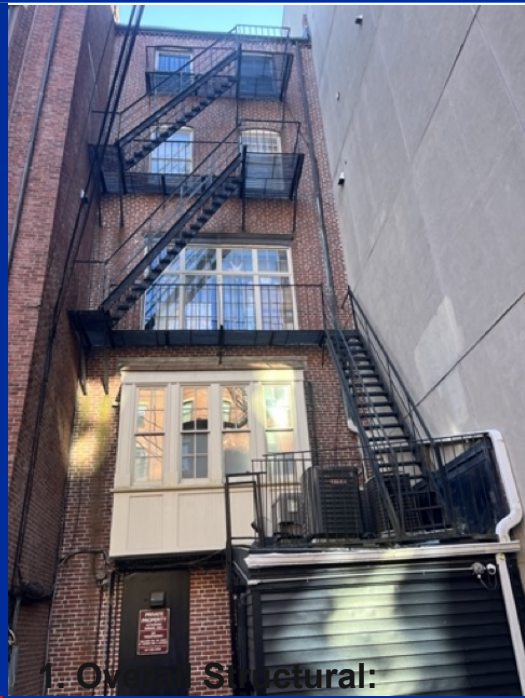
This pre load test evaluation was requested at this location to confirm that the fire escape system is structurally sound and has been kept painted as is required by code. Certification can be done by load test, other evidence of strength or an opinion affidavit with a disclaimer of liability waiver form. This is a five story brick building with a fire escape system made of painted steel and consisting of platforms with stairs and a ladder to grade. This system did not pass due to the following major issues:

- Supports** - Surface rust was detected on the supports, and some minor rust jacking was noted in a few returns. The original hardware remains but is showing signs of deterioration.

- Grating/ Platforms** - Some deflection was observed in the platforms. Blown spacers are present, and internal rust was found in the clips. The original hardware remains in place.

- Rails** - Minor internal rust is present on the railings. Connections to the brick wall include a washer that is being used as a shim that needs attention.

- Stringers** - There is some rust jacking in certain areas. A potential missing angle was identified in one section, which may need further evaluation.

- Treads** - Some of the welded treads appear to be homemade replacements. A load test is recommended to verify the integrity of the welded repairs. Some treads are in poor condition due to rust jacking and deteriorated spacers and should be fully replaced.

- Fixed Ladder** - Fair condition, but lands on concrete stair.
- Catwalk** - Needs proper framing and sleepers to allow for better snow clearance.
- Cement/ Footings** - Concrete stair under ladder could create a tripping hazard.

1. Overall Structural:  
**Poor/Fail**  
50-75%

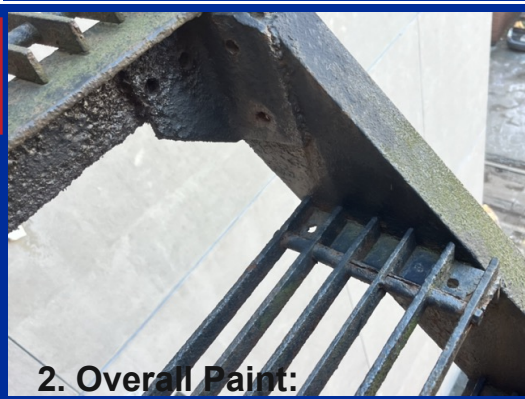
2. Overall Paint:  
**Poor/Fail**  
75-100%

Overall the paint FAIL: Full paint on system required after repairs. Recommend to power wash and seal all major joints to prevent water intrusion into structural connections. Fire Escapes, must be maintained/ painted every 5-7 years as per manufactures recommendation.

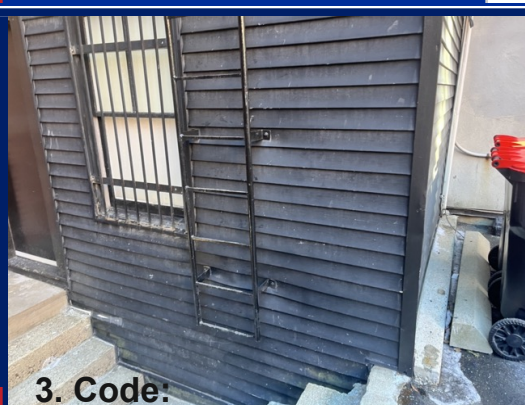
3. Code:  
**Issues Exist**  
25%

- Concrete stair under ladder could create a tripping hazard.
- Egress system may require lighting upgrade to satisfy code requirements.
