FIRE ESCAPE ENGINEERS

PRE-LOAD TEST EVALUATION RESULTS

PERFORMED AT: **C**
side
39-45 Newbury St Boston MA

INSPECTION DATE **January 14 2025**
REPORT DATE **March 10 2025**
REPORT EXPIRES **April 10 2025**

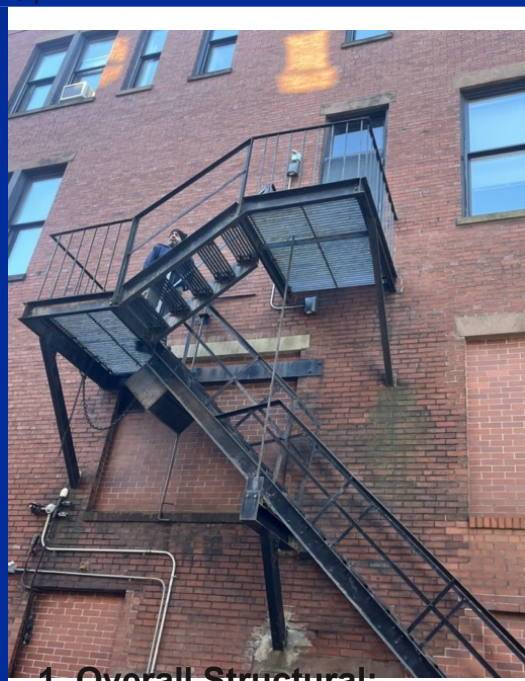
1. Overall Structural:

Poor/Fail

50%

This pre load test evaluation was requested at this location to confirm that the fire escape system is structurally sound and has been kept painted as is required by code. Certification can be done by load test, other evidence of strength or an opinion affidavit with a disclaimer of liability waiver form. This is a six story brick building with a fire escape system made of painted steel and consisting of platforms with stairs and a cantilever to grade. This system did not pass due to the following minor issues:

SUPPORTS: Welded and original bolted connections observed. Needs further investigation or load testing, only one return bracket present on each platform.

PLATFORMS: Internal rust present in platform frame.

RAILS: Internal rust in railing bottom flats.

STRINGERS: Internal rust in stringer clips is beginning to cause rust jacking.

TREADS: Original treads with spacers have internal rust in tread clips. New treads installed on cantilever.

CANTILEVER: New treads installed, some rust present, obsolete operation of release arm. Needs rebalancing and routine maintenance to pivot point.

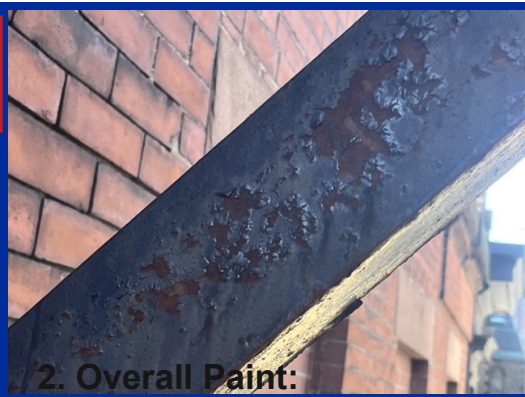
2. Overall Paint:

Poor/Fail

50-75%

Overall the paint FAIL: Full paint on system required after repairs. Recommend to power wash and seal all major joints to prevent water intrusion into structural connections.
Fire Escapes, must be maintained/ painted every 5-7 years as per manufactures recommendation.

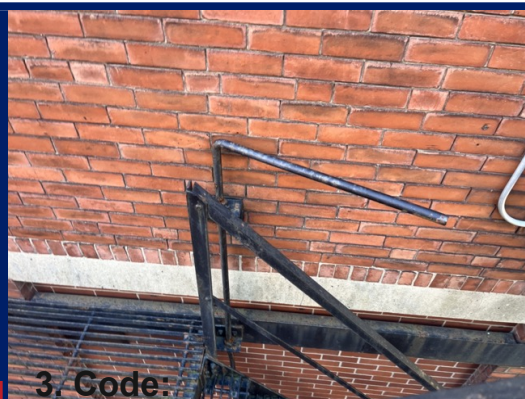
3. Code:

Issues Exist

25%

Our inspector found code issues related to AHJ (Authority Having Jurisdiction) or PENC (pre-existing non-conforming) requirements for this Fire Escape system.

- Egress system may require code upgrade for lighting.
- Flammables (Dumpster) under system.
