Sal Monteneri  
39-45 Newbury St (Roof  
Elevator room)  
5901 MA 02116  
Case Number

Steel & Wood  
Catwalk

Jan/29/25  
Inspection Date  
Mar/10/25  
Report Date  
Apr/10/25  
Report Expires

# FAILED MINOR

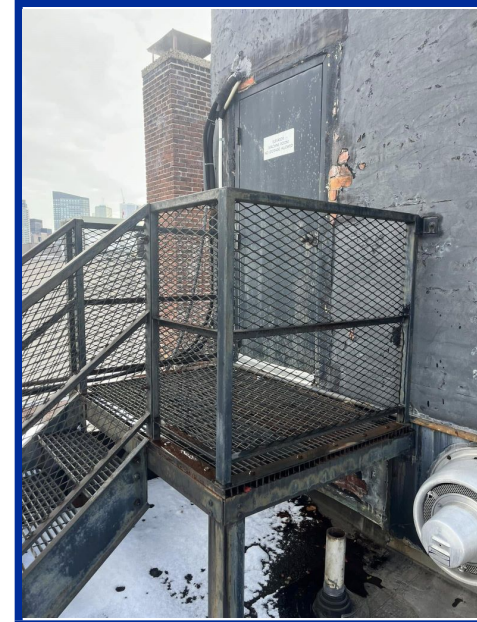
1. Overall Structural:

15. Misc. Notes: **There is internal rust present in the tread and stringer clips. Additionally, the legs of the system lack protective pads and require sleepers to properly distribute the load and prevent deterioration of the contact surface.**

Poor/Fail

25-50%

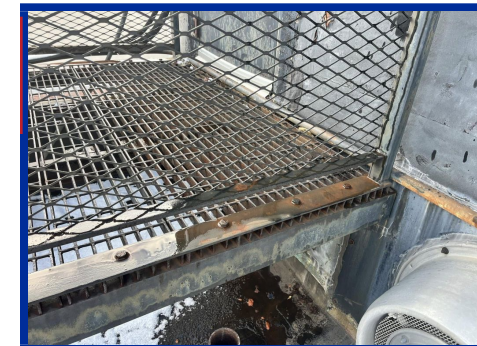
2. Overall Paint:

Poor/Fail

100%

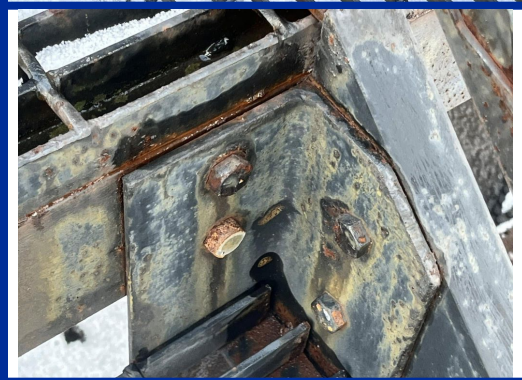
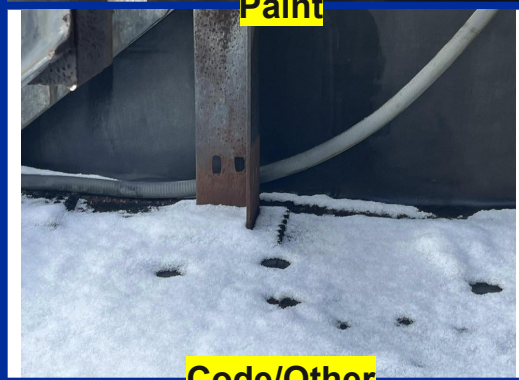
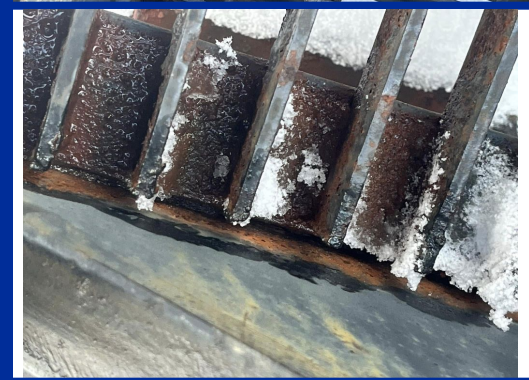
Paint

Fail
