PRE-LOAD TEST EVALUATION RESULTS

PERFORMED AT: **E**
side
39-45 Newbury St (Roof) Boston MA

INSPECTION DATE **January 14 2025**
REPORT DATE **March 10 2025**
REPORT EXPIRES **April 10 2025**

PRE-LOAD TEST INITIAL EVALUATION PASS/FAIL REPORT

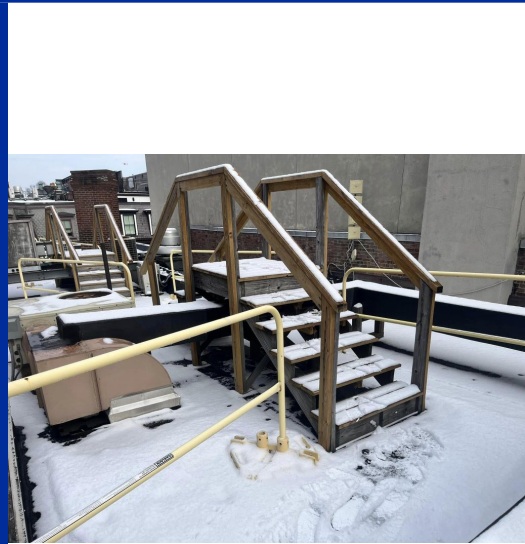
1. Overall Structural:

Poor/Fail

This pre load test evaluation was requested at this location to confirm that the fire escape system is structurally sound and has been kept painted as is required by code. Certification can be done by load test, other evidence of strength or an opinion affidavit with a disclaimer of liability waiver form. This is a six story brick building with a fire escape system made of painted steel as well as wood and consisting of platforms with stairs and a stair well to grade. This system did not pass due to the following major issues:

SUPPORTS: On the steel stair, several bolts securing the platform are either loose or missing, compromising structural stability and safety.

PLATFORMS: The steel stair is missing a landing platform, making transitions unsafe and non-compliant with egress requirements. Installing a properly sized and secured platform is necessary to ensure safe movement and adherence to safety standards.

RAILS: The railing on the wooden stair closest to the alleyway is loose, compromising safety and stability. Reinforcement or reattachment is necessary to restore structural integrity.

STRINGERS: On the steel stair, the stringer bolts, which also serve as structural supports, are either loose or missing.

TREADS: Internal rust is beginning to cause rust jacking in the tread clips with the bolted hardware, leading to potential expansion and weakening of the connections. If left unaddressed, this could compromise the structural integrity of the bolts and stair system.

CATWALK: The egress path is incomplete due to the absence of a catwalk across the roof, which should connect both exits and lead to the stairwell.

OTHER: -The wooden systems are constructed partially using kiln-dried wood instead of pressure-treated wood, which reduces resistance to moisture, decay, and long-term durability in exterior conditions.

-The system may require an emergency lighting upgrade to ensure adequate illumination of the egress path during low-light conditions or power outages.

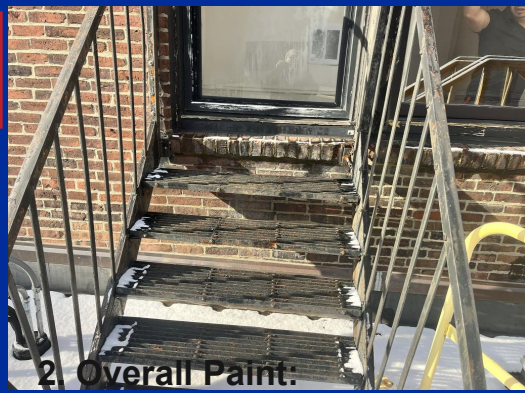
2. Overall Paint:

Poor/Fail

Overall the paint FAIL: Full paint on system required after repairs. Recommend to power wash and seal all major joints to prevent water intrusion into structural connections.

Fire Escapes, must be maintained/ painted every 5-7 years as per manufactures recommendation.

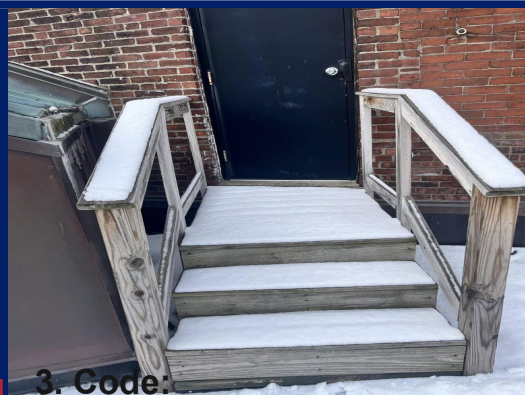
3. Code:

Issues Exist

Our inspector found code issues related to AHJ (Authority Having Jurisdiction) or PENC (pre-existing non-conforming) requirements for this Fire Escape system.

-Egress system may require code upgrade for emergency lighting.

-Missing platform and catwalks.
