## SB-721 INSPECTION FINDINGS

**C 1751 (C-side) 721 Wood St (1751 C-side) Oakland** **AKLAND BALCONY COMPLIANCE**

**721 Wood St (1751 C-side) Oakland CA**

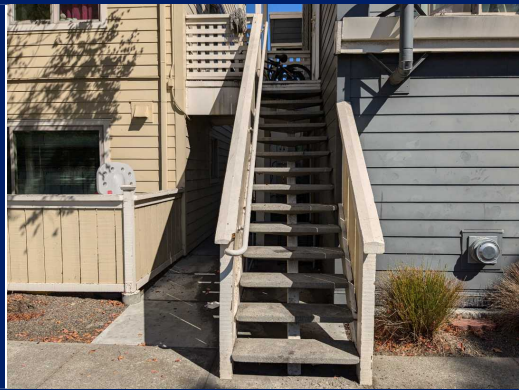
Railings: Fail. Minor repairs required. One picket has rotted from the bottom and is disconnected.

Treads: Pass pending, as concrete treads have cracks and spalling from water intrusion.

Stringers: Pass, though rust and corrosion is forming at tread welded connections and bolted clips. Recommend cleaning, painting, and sealing.
