## SB-721 INSPECTION FINDINGS

### PHASE 1 & 2 PASS

**A** 1761 (A-side) **721 Wood St (1761 A-side) Oakland** **OAKLAND BALCONY COMPLIANCE**

## 721 Wood St (1761 A-side) Oakland CA

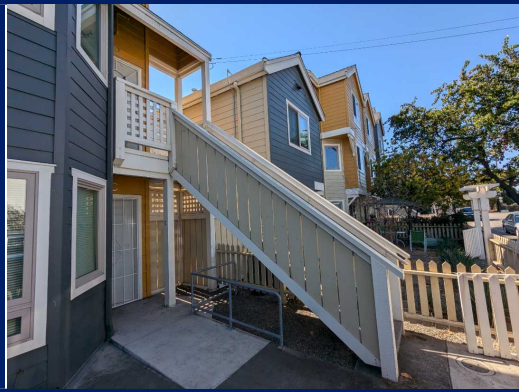
Associated waterproofing: Pass, membrane has no issues noted.

Exterior of elevated elements: Pass

Railings: Pass

Platforms: Pass

Treads: Pass.

Stringers: Pass, though rust and corrosion is forming at tread welded connections.

Recommend cleaning, painting, and sealing.

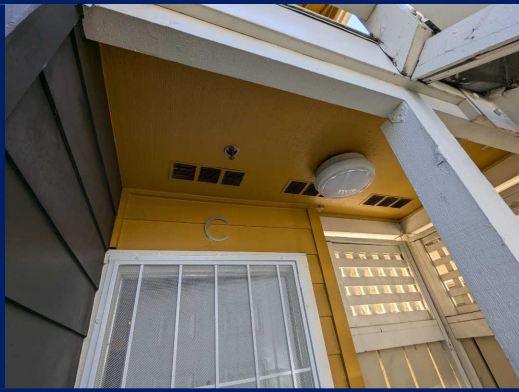
Load-bearing components: Pass. No signs of water intrusion, organic growth, or found in accessed concealed spaces on date of inspection.

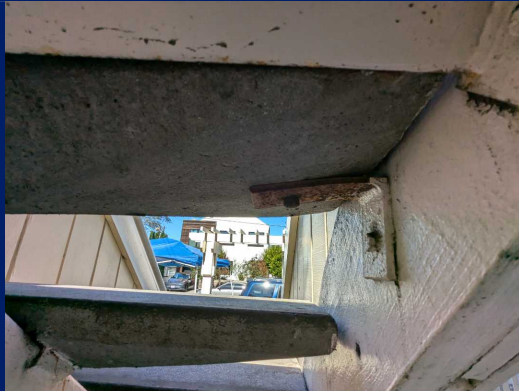
Overall the paint and waterproofing PASS:

Our inspector found no code issues related to AHJ (Authority Having Jurisdiction) or PENC (pre-existing non-conforming) requirements for this system.
