SB-721 INSPECTION FINDINGS

B 1781 (C-side) 721 Wood St (1781 C-side) Oakland **AKLAND BALCONY COMPLIANCE**

721 Wood St (1781 C-side) Oakland CA

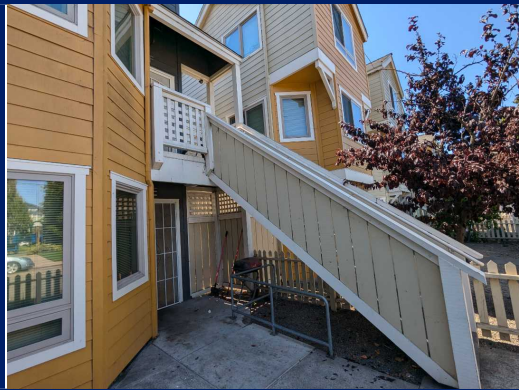
Railings: Pass pending required maintenance and repair of slipping railing infill lattice.

Minor vegetation growing in some railing top seams.

Treads: Pass, though cracks are starting to propagate. Recommend repack and seal.

Stringers: Pass, though rust and corrosion is forming at tread welded connections.

Recommend cleaning, painting, and sealing.

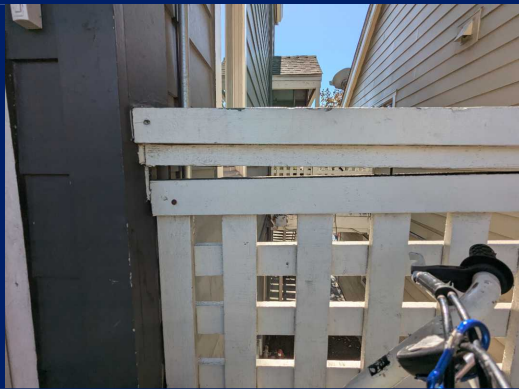
Load-bearing components: Pass. No signs of water intrusion, organic growth, or found in accessed concealed spaces on date of inspection.

Final results: System is functional and safe. No immediate threats exist.

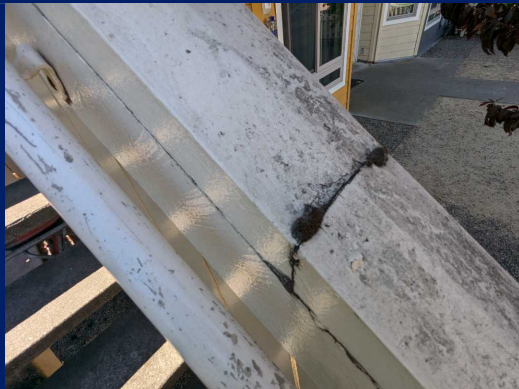
Overall the paint and waterproofing PASS:

Our inspector found no code issues related to AHJ (Authority Having Jurisdiction) or PENC (pre-existing non-conforming) requirements for this system.
