PRE-LOAD TEST EVALUATION RESULTS

PERFORMED AT: **C**
side
29-33 Newbury St Boston MA

INSPECTION DATE **January 14 2025**
REPORT DATE **March 10 2025**
REPORT EXPIRES **April 10 2025**

PRE-LOAD TEST INITIAL EVALUATION PASS/FAIL REPORT

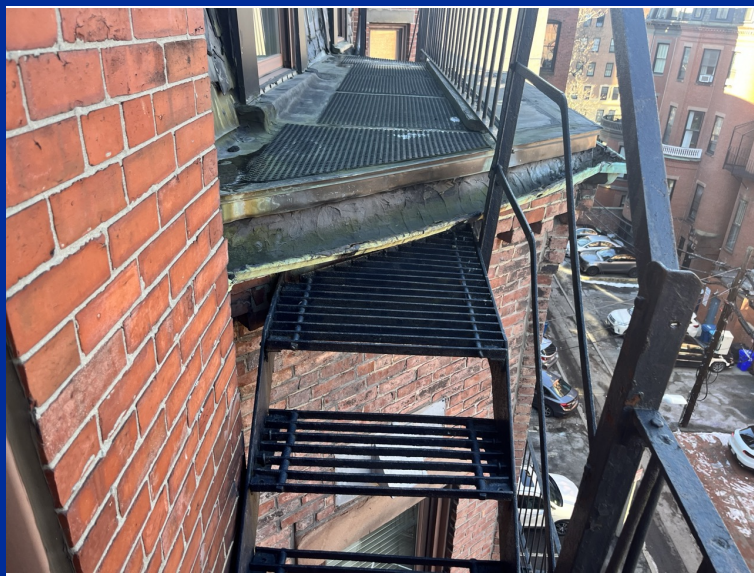
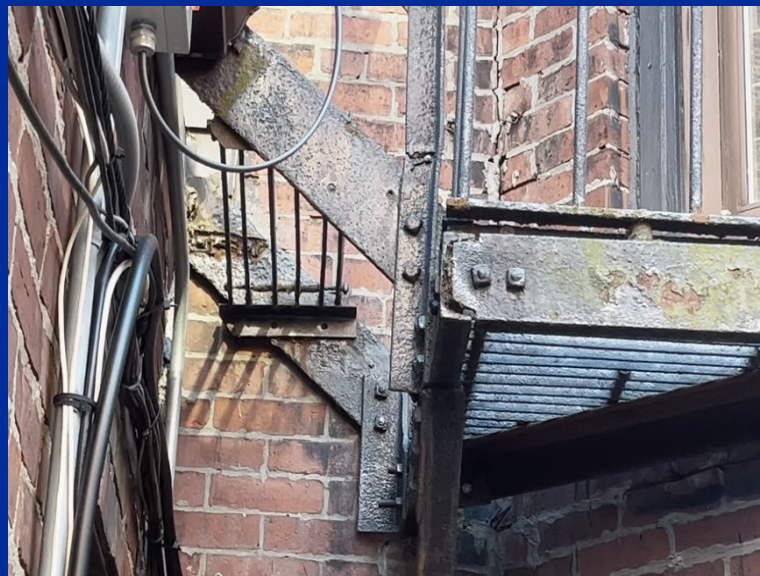
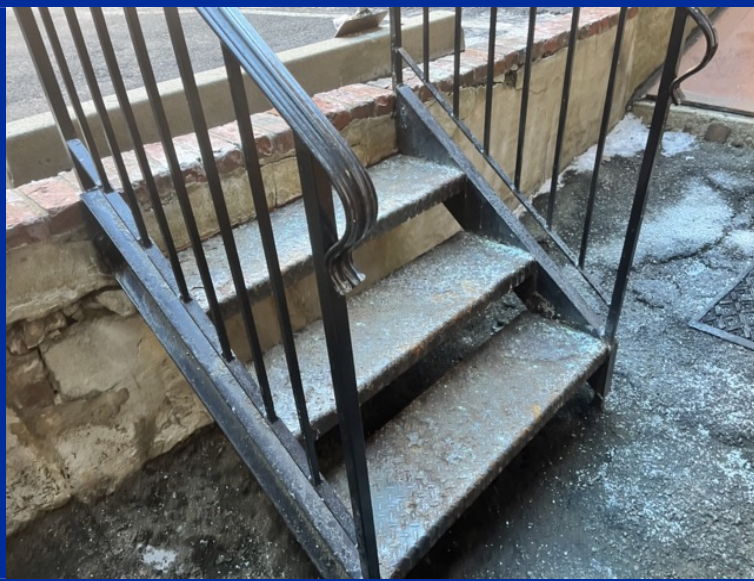
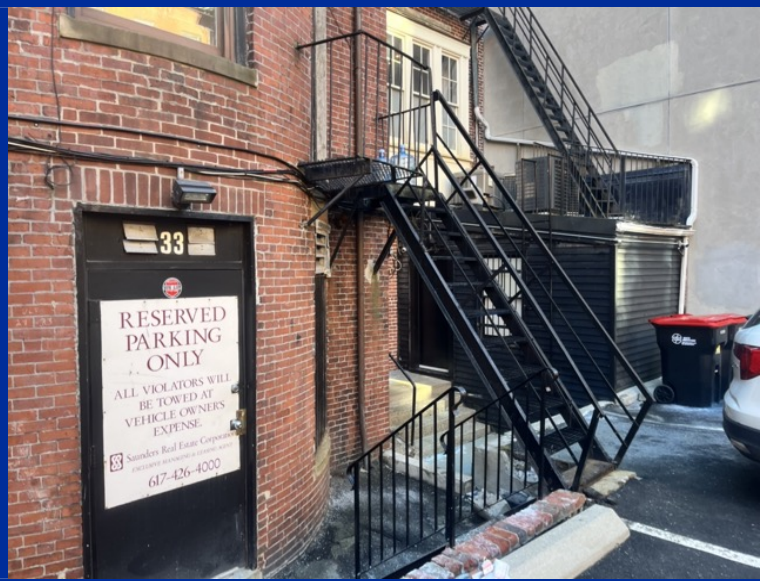
pg 2

| Overall Structural | Overall Paint | Supports/ Cement | Grating/ Platforms | Rails | Stringers | Treads | Cantilever/ Balanced | Fixed Ladder | Cement Pads & Footings | Catwalk | |
|---|---|---|---|---|---|---|---|---|---|---|---|
| <input checked="" type="checkbox"/> Poor/Fail | <input checked="" type="checkbox"/> | <input checked="" type="checkbox"/> | <input checked="" type="checkbox"/> | <input checked="" type="checkbox"/> | <input checked="" type="checkbox"/> | <input checked="" type="checkbox"/> | <input type="checkbox"/> | <input type="checkbox"/> | <input checked="" type="checkbox"/> | <input type="checkbox"/> | |
| 50% | Percent Fail | 50-75% | 25% | 50-75% | 25-50% | 25% | 50% | N/A | N/A | 75-100% | 100% |
