## PRE-LOAD TEST EVALUATION RESULTS

PERFORMED AT: **C**  
side  
**35 Newbury St Boston MA**

INSPECTION DATE **January 14 2025**  
REPORT DATE **March 10 2025**  
REPORT EXPIRES **April 10 2025**

PREPARED BY:  
**FIRE ESCAPE ENGINEERS**

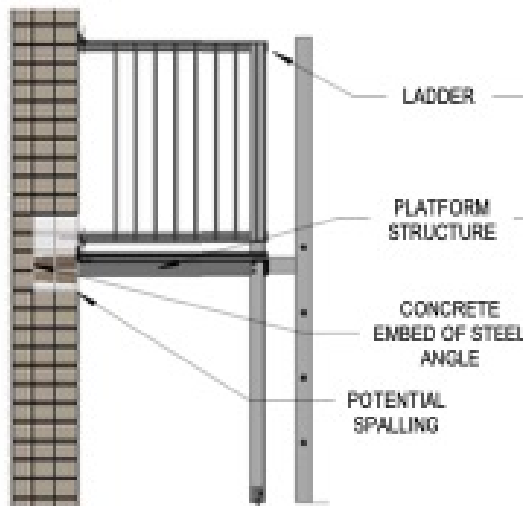
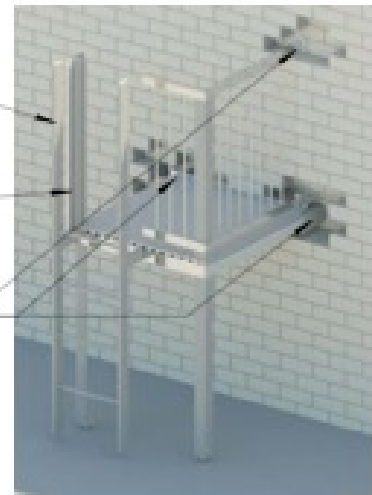
**3** L1-BALCONY AND LADDER  
SCALE: 3/8" = 1'-0"

14) Fixed Ladders to Roof and/or to Grade & Bolts and/or Welds **Pass RLT**  
are structurally sound having NO material deterioration - NO internal rust jacking or external surface rust or wood rot or spauling  
Overall Fixed Ladder PASS. Pending load test or other evidence of strength otherwise liability disclaimer letter signed by owner.

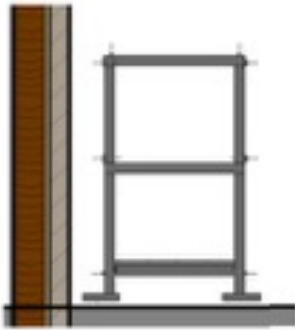
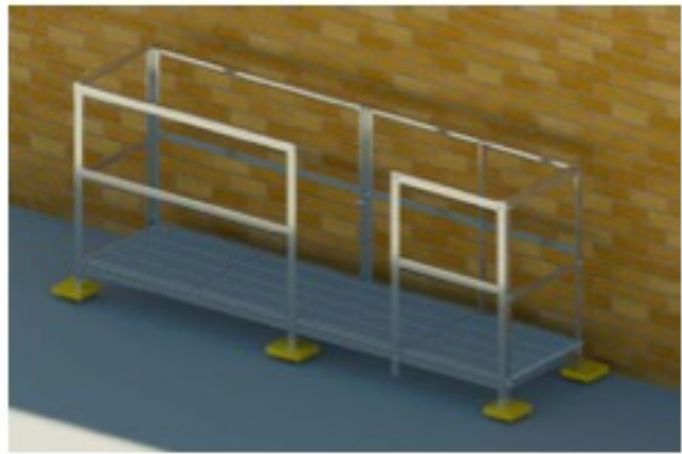
1 C3-CATWALK AND COMPONENTS  
SCALE: 3/8" = 1'-0"

17) Catwalks & Bolts and/or Welds **Fail Minor**  
are structurally sound having NO material deterioration - NO internal rust jacking or external surface rust and lead to the fire escape and completes to grade  
Overall Minor Structural on Catwalk FAIL: Not industry standard construction.
