FIRE ESCAPE ENGINEERS

PRE-LOAD TEST EVALUATION RESULTS

PERFORMED AT: **C**
side
39-45 Newbury St Boston MA

INSPECTION DATE **January 14 2025**
REPORT DATE **March 10 2025**
REPORT EXPIRES **April 10 2025**

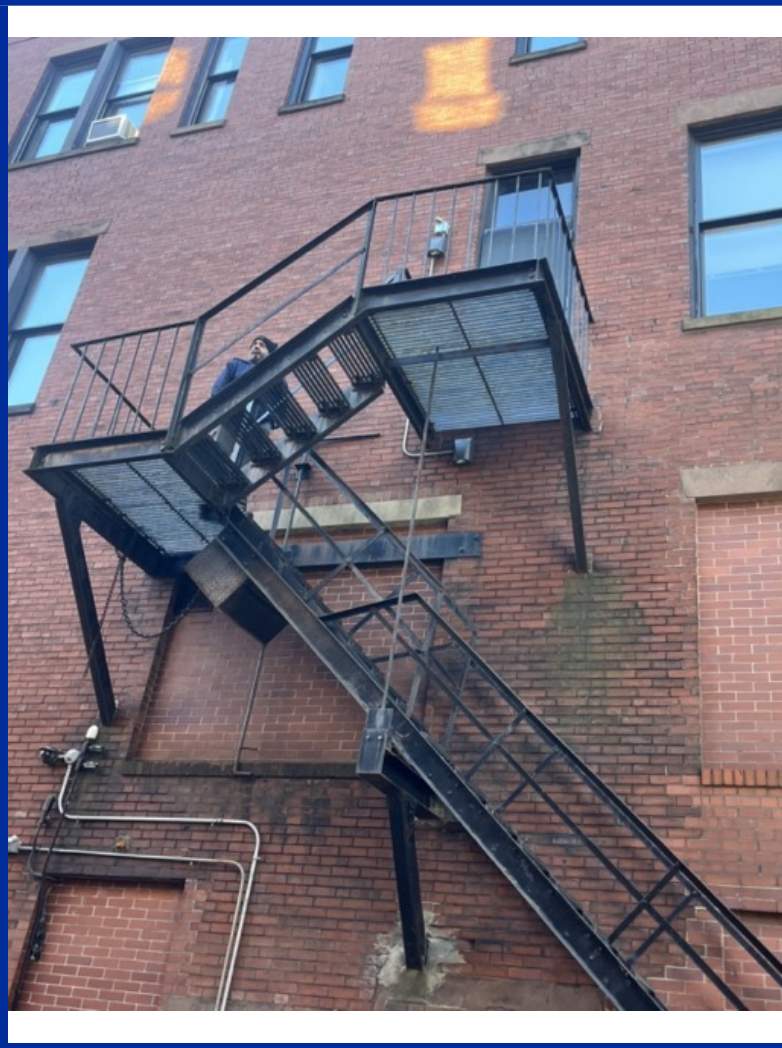
FAILED MINOR

Overall Minor Structural FAIL. Internal rust causing Rust Jacking (RJ) of some suspect connections.

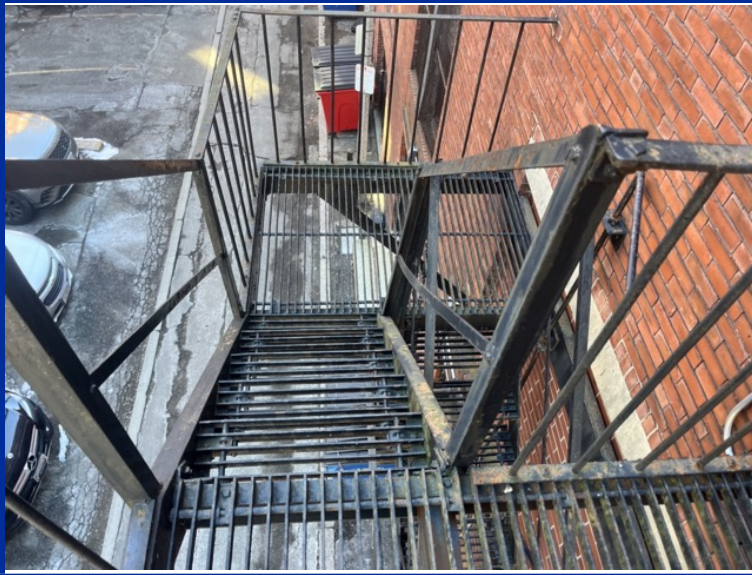
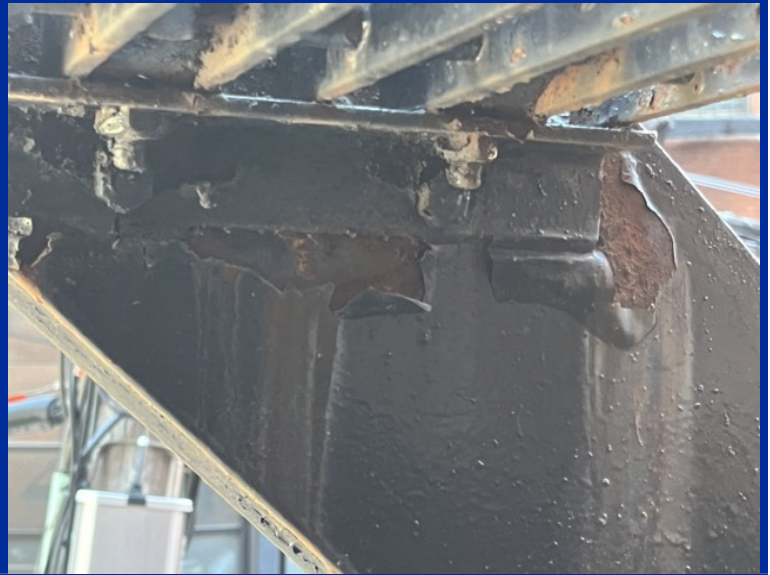
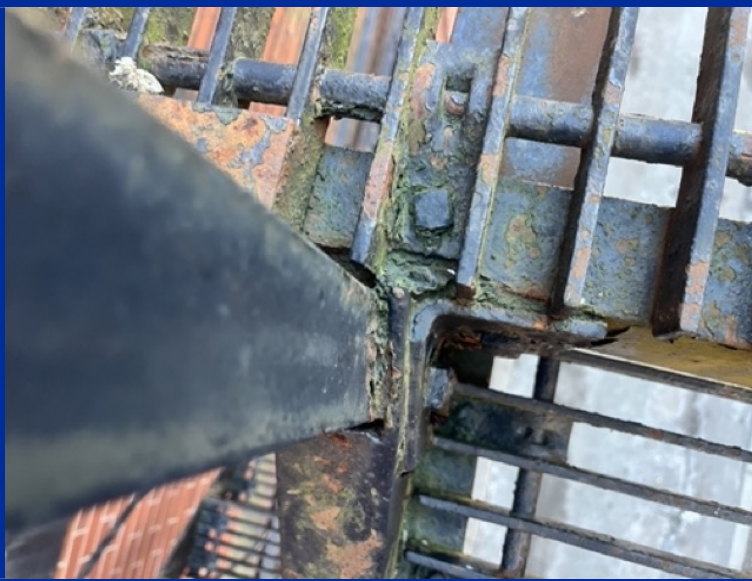
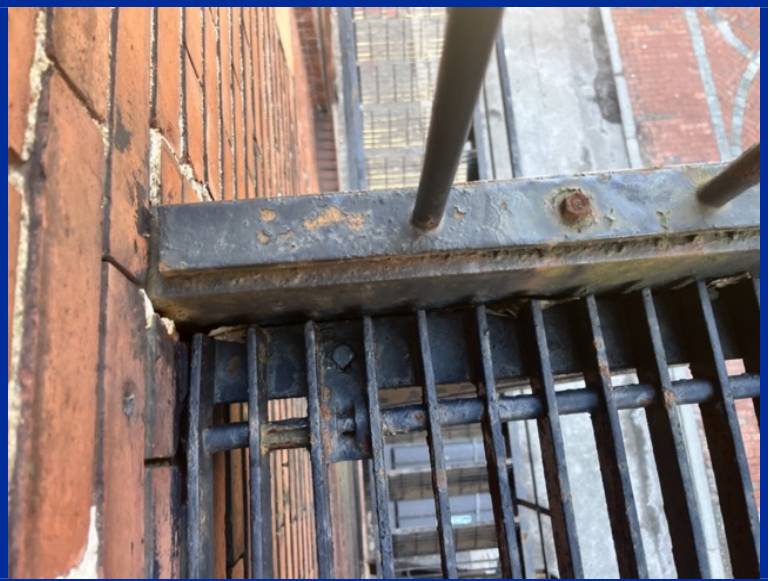
Overall Paint FAIL. Lack of routine maintenance requiring Full scrape, prime, seal, and paint.

Overall Minor Structural Supports (bracket, thru-bolt, legs) FAIL: Possible components missing. Requires load testing or further investigation.

Overall Minor Structural Platforms, Slats, Grating FAIL. Internal rust causing Rust Jacking (RJ) of some suspect connections.

Overall Minor Stair Stringers FAIL Internal rust causing rust jacking (RJ) of some suspect connections.

Overall Minor Structural Treads FAIL. Internal rust causing Rust Jacking (RJ) of some suspect connections.

ALL FIRE ESCAPES MUST BE STRUCTURALLY SOUND AND KEPT PAINTED AS PER CODE. Structural connections must be free of all internal rust and sealed from water intrusion. Spot paint every 3-5 years, full paint every 7-10 years and maintain sealant on all critical structural connections.

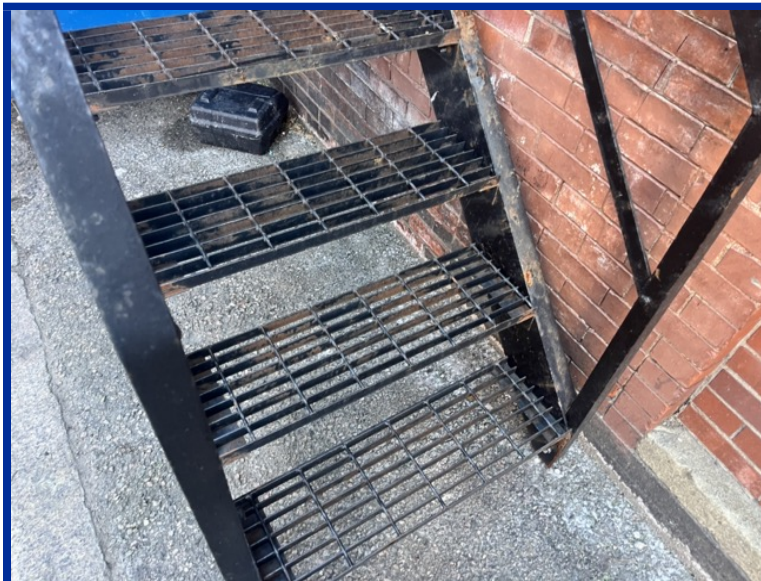
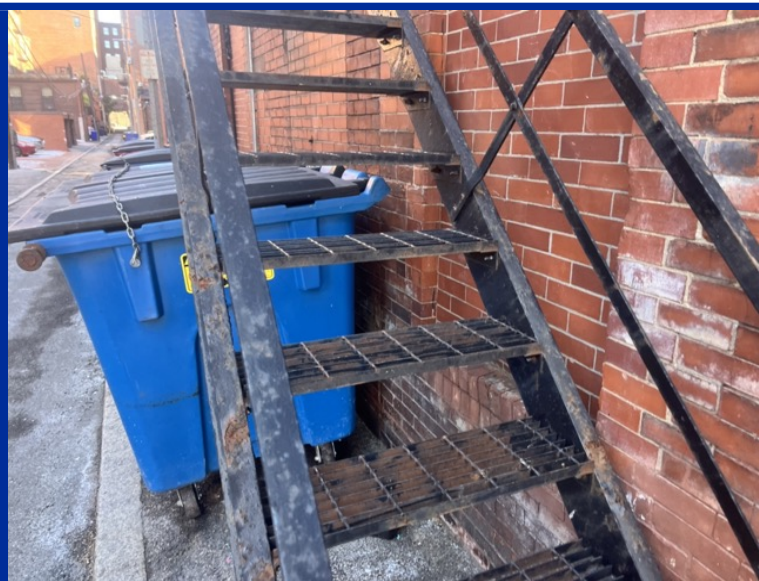
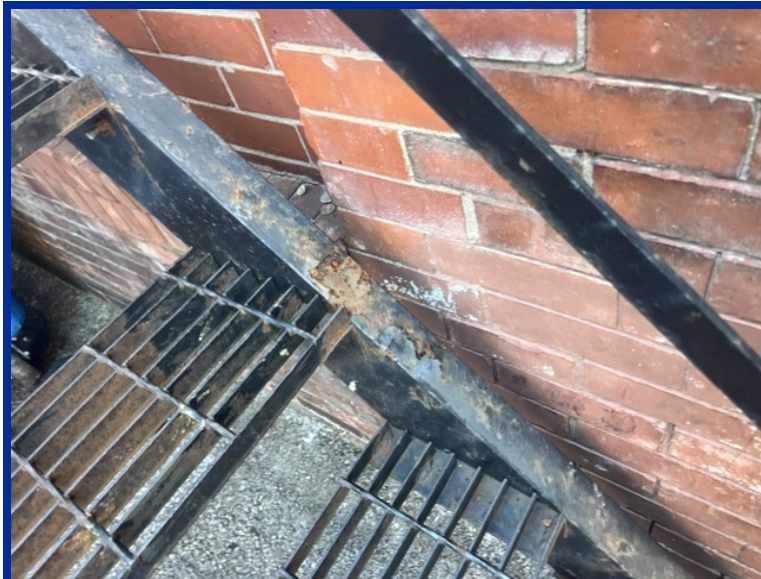
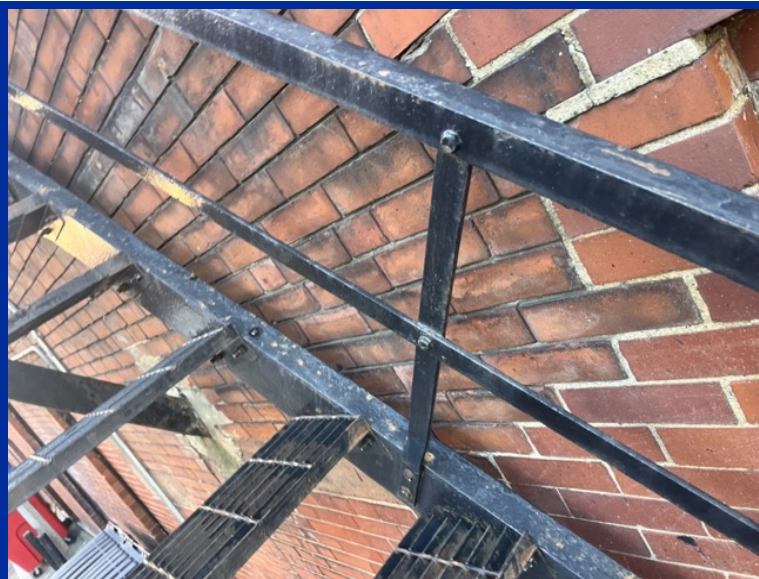
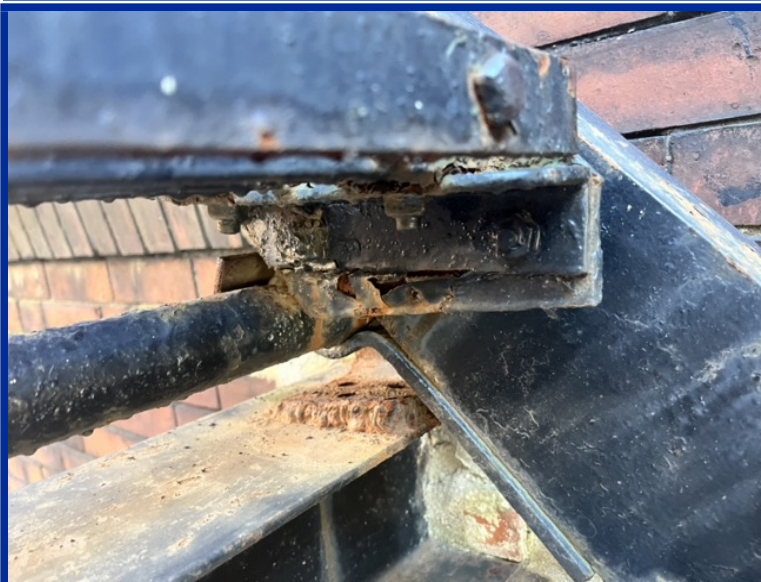
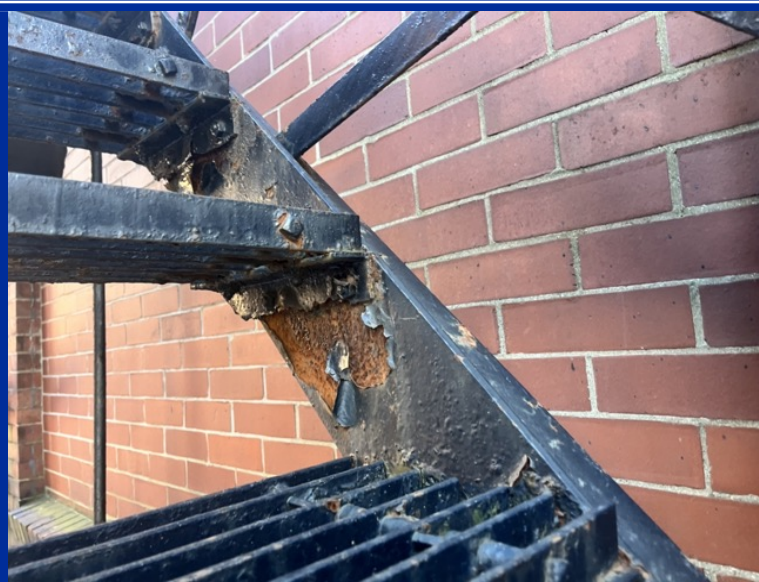
SUPPORTS: Welded and original bolted connections observed. Needs further investigation or load testing, only one return bracket present on each platform.

PLATFORMS: Internal rust present in platform frame.

RAILS: Internal rust in railing bottom flats.

STRINGERS: Internal rust in stringer clips is beginning to cause rust jacking.

TREADS: Original treads with spacers have internal rust in tread clips. New treads installed on cantilever.
