## SB-721 INSPECTION FINDINGS

**C 1751 (C-side) 721 Wood St (1751 C-side) Oakland** **AKLAND BALCONY COMPLIANCE**

**721 Wood St (1751 C-side) Oakland CA**

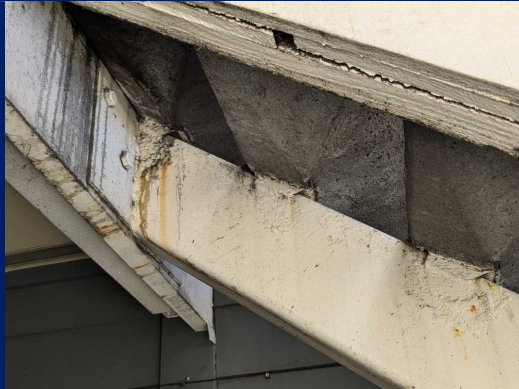
Overall the paint and waterproofing PASS:

Our inspector found no code issues related to AHJ (Authority Having Jurisdiction) or PENC (pre-existing non-conforming) requirements for this system.
