SB-721 INSPECTION FINDINGS

B 1781 (C-side) 721 Wood St (1781 C-side) Oakland **AKLAND BALCONY COMPLIANCE**

721 Wood St (1781 C-side) Oakland CA

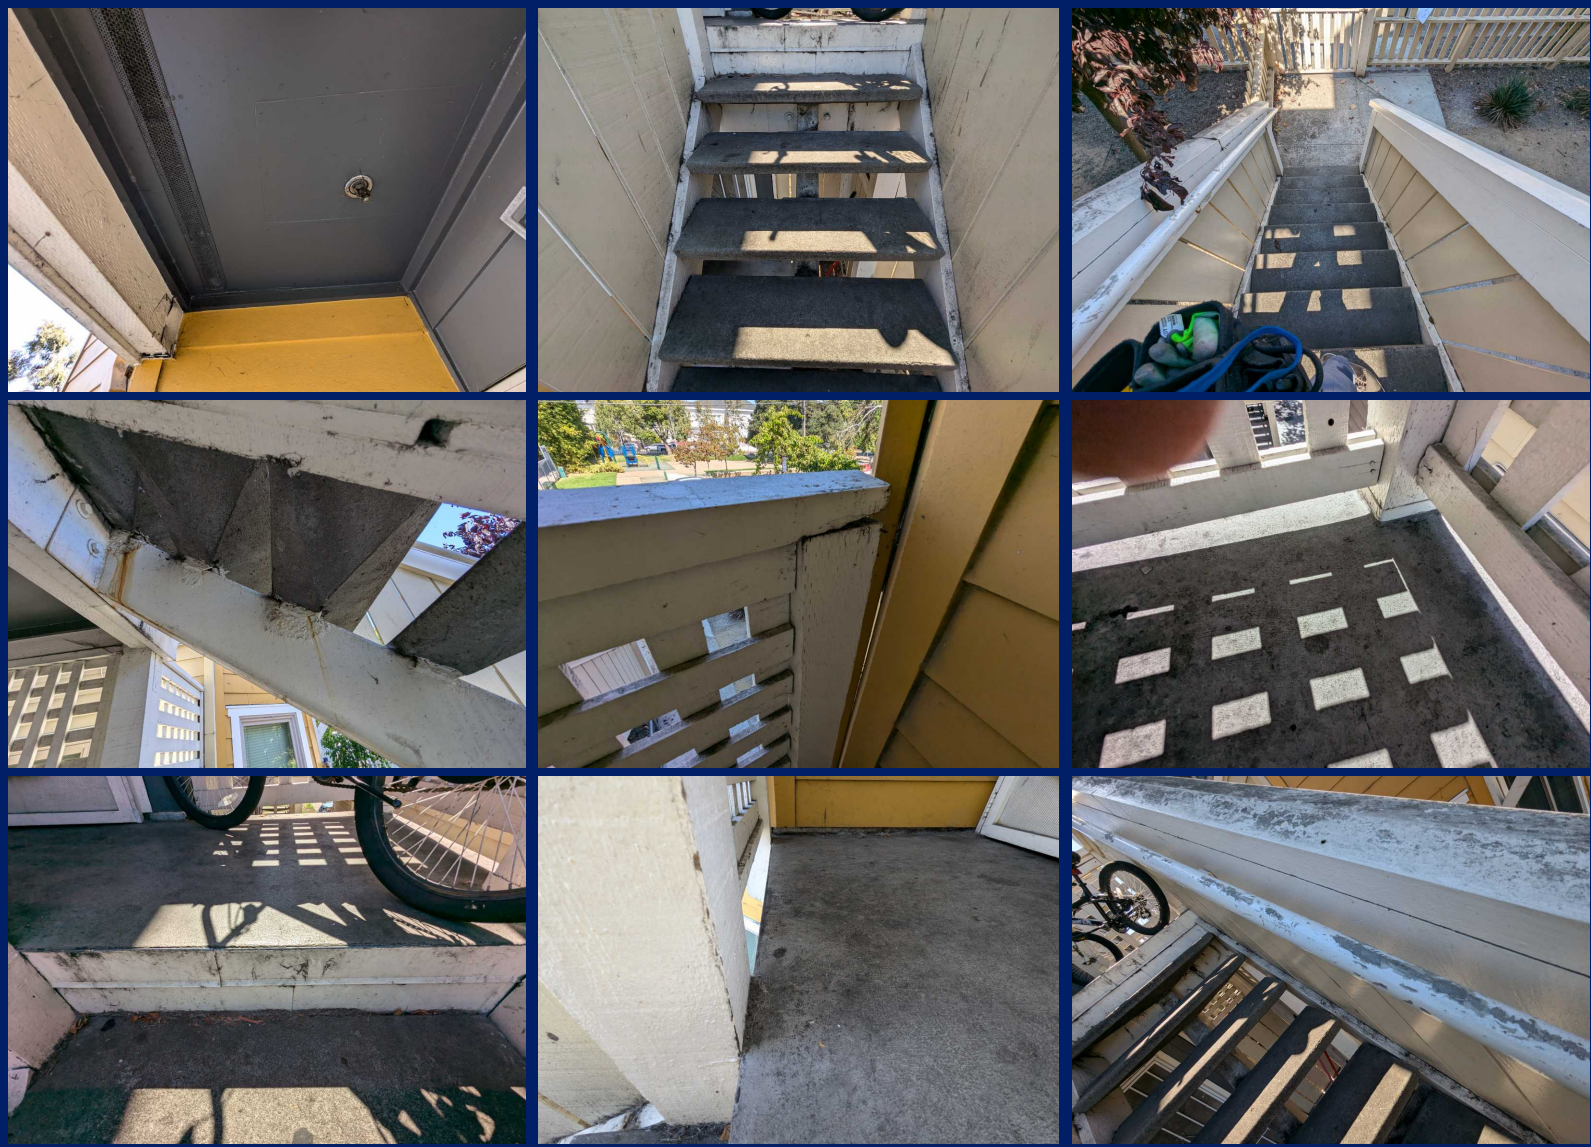
Structural	Railing	Membrane	Paint/Stain	Code
% failure	0%	0-25%	0%	0%	0%

Railings: Pass pending required maintenance and repair of slipping railing infill lattice.
