## PRE-LOAD TEST EVALUATION RESULTS

PERFORMED AT: **C**  
side  
**SAMPLE ADDRESS City STATE**

INSPECTION DATE **December 6 2024**  
REPORT DATE **December 10 2024**  
REPORT EXPIRES **January 10 2025**

# PRE-LOAD TEST INITIAL EVALUATION PASS/FAIL REPORT

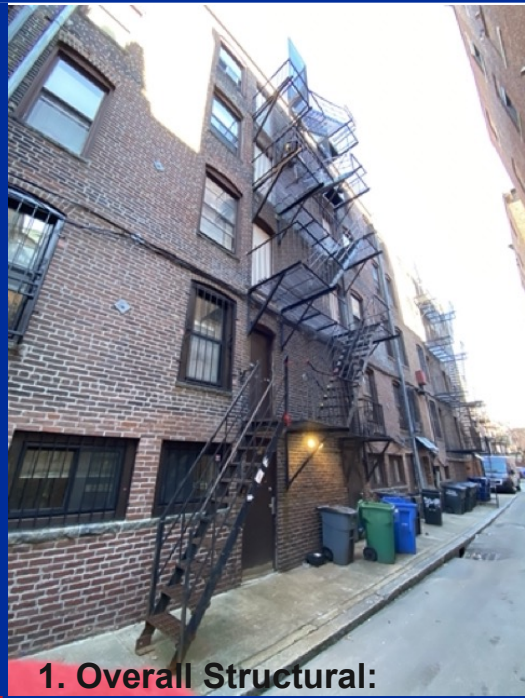
This pre load test evaluation was requested at this location to confirm that the fire escape system is structurally sound and has been kept painted as is required by code. Certification can be done by load test, other evidence of strength or an opinion affidavit with a disclaimer of liability waiver form. This is a five story brick building with a fire escape system made of painted steel and consisting of platforms with stairs to grade. This system did not pass due to the following major issues and imminent safety hazards:

**Supports** - Rust jacking in angles, undersize hardware, cement work needed at most connections to building. The platforms are sloping away from the building and require further investigation.

**Grating/ Platforms** - The platform spacers are deteriorating due to excessive internal rust and need to be reinforced.

**Rails** - Imminent safety hazard - The lowest platform was impacted by a vehicle and the railings are loose. Additionally the railings on the platforms have pulled from the building due to the fact that the platform is leaning away from the building.

**Stringers** - Imminent safety hazard - Missing hardware and suspect welds

**Treads** - Imminent safety hazard - Internal rust is causing severe rust jacking in many connections.

**Cement/ Footings** - Suspect due to vehicle impact.

**Other** - Wall has multiple areas that are bulging and are suspect.

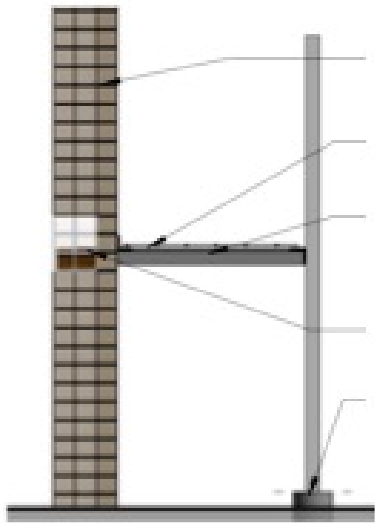
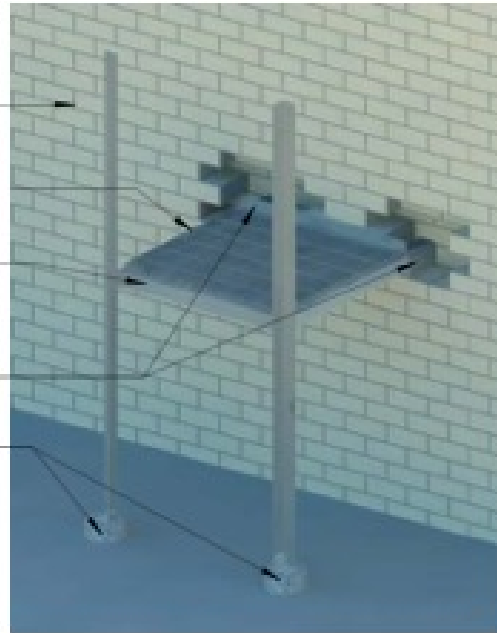
1 S3-BALC-WITH-POST-TO-GROUND  
SCALE: 3/8" = 1'-0"

EXISTING BRICK WALL  
METAL GRATE WITH SPACERS AND BOLTS  
PLATFORM STRUCTURE  
CONCRETE EMBED OF STEEL ANGLE  
FOOTING

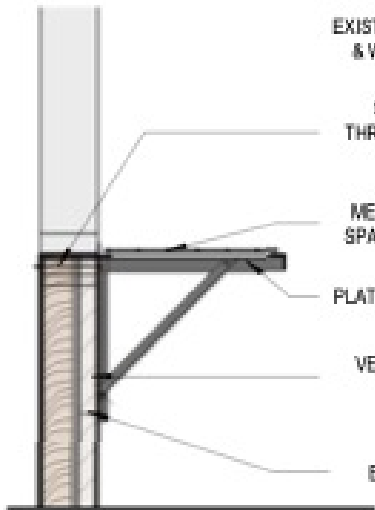
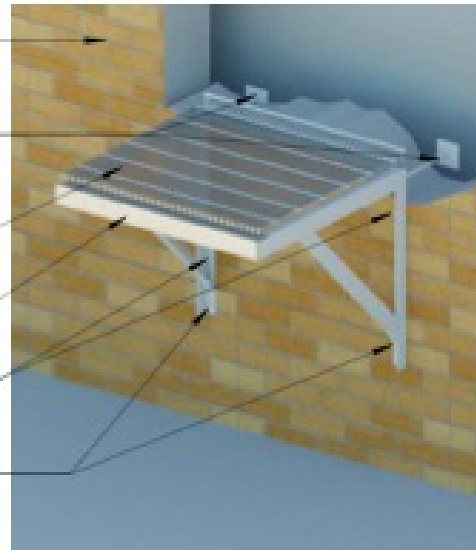
3 S4-BALC-WITH-THRU BOLT & PLATE  
SCALE: 3/8" = 1'-0"

EXISTING BRICK VENEER & WOOD STUD WALL  
STEEL PLATE, THREADED ROD AND FASTENERS  
METAL GRATE WITH SPACERS AND BOLTS  
PLATFORM STRUCTURE  
VERTICAL ANGLE SUPPORT  
EXPANSION BOLT

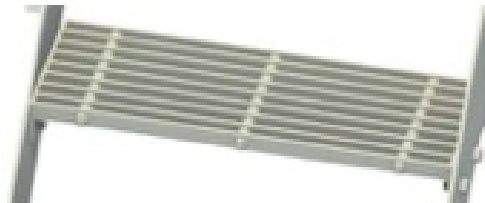
10 G1-3D-EVAL-TREAD  
SCALE: 1/2" = 1'-0"

BAR GRATE WITH  
SPACES AND A THRU  
BOLT

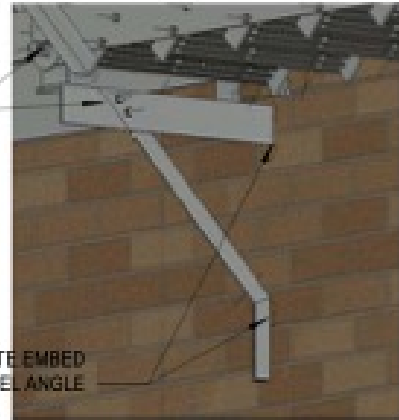
1 C1-STAIR CANTILEVER

LOWER CANTILEVER STAIR RELEASE ROD AND PUSH BAR
